HYDROGEOMORPHIC EVALUATION OF
ECOSYSTEM RESTORATION
AND MANAGEMENT OPTIONS
FOR
CAPE ROMAIN NATIONAL WILDLIFE REFUGE

Greenbrier Wetland Services
Report No. 14-08

December 2014

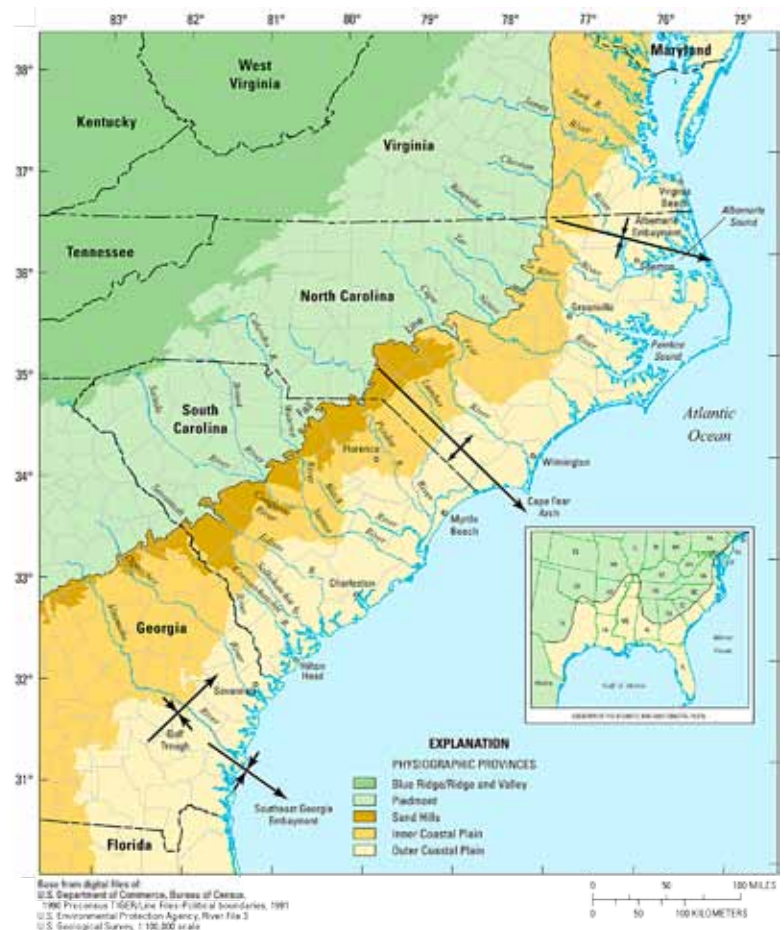
Figure 3. Physiographic provinces along the south Atlantic coast in relationship to geological attributes. Cape Romain is located within the Outer Coastal Plain physiographic province along the coast between Charleston and the Santee River (from Campbell et al. 2011).

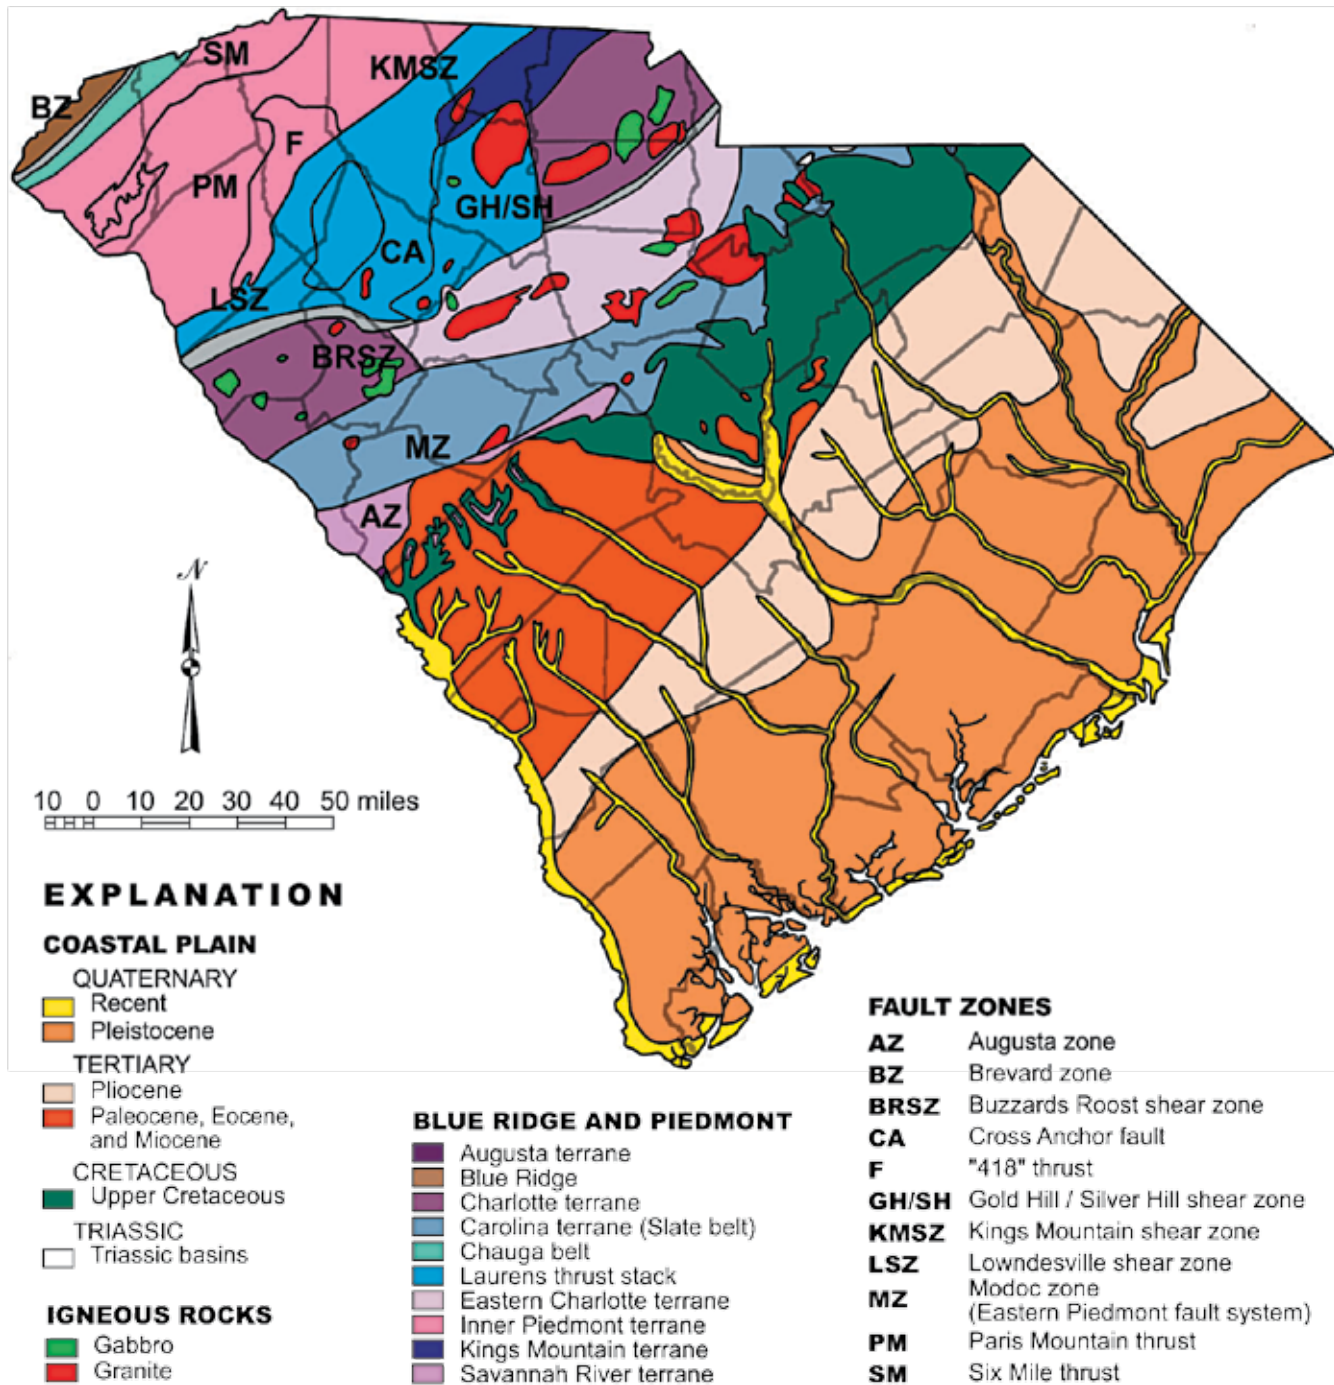
Figure 4. Geological map of South Carolina (from Harris et al. 2005). The Atlantic Coastal Plain contains the Coastal Plain and Continental Shelf from the Piedmont Province to the submerged edge of the Continent. This shelf thickens to the southeast and is comprised of Cretaceous, Tertiary, and Quaternary rocks of unlithified sediments interbedded with sedimentary rocks. Quaternary rocks at Cape Romain National Wildlife Refuge are underlain by Eocene formations consisting of limestone and Tertiary sands.

the Piedmont Province to the submerged edge of the continent. This shelf thickens to the southeast and is comprised of Cretaceous, Tertiary, and Quaternary rocks of unlithified sediments interbedded with sedimentary rocks (Fig. 4, Weems and Lewis 2002, Cooke

the lowest elevation area of South Carolina characterized by Quarternary materials (Figs. 4, 5). The South Carolina Coastal Plain ranges in elevation from 0 to 50 feet above sea level (National Geodetic Vertical Datum of 1929). Unconsolidated materials composed of sand, silt, and clay have been deposited and form a variety of relatively gently rolling features including beaches, dunes, marsh, terrace, and nearshore marine deposits (Fig. 9, Campbell and Coes 2010). Light Detection and Ranging (LiDAR) elevation surveys have been completed for northern Charleston County, but are not completely processed or available at this time. Currently, processed LiDAR data are only available at two-foot contour intervals (Fig. 10). This gross-level topographic data mapping precludes definition of the many modest (< 1-2 feet) elevation changes asso-

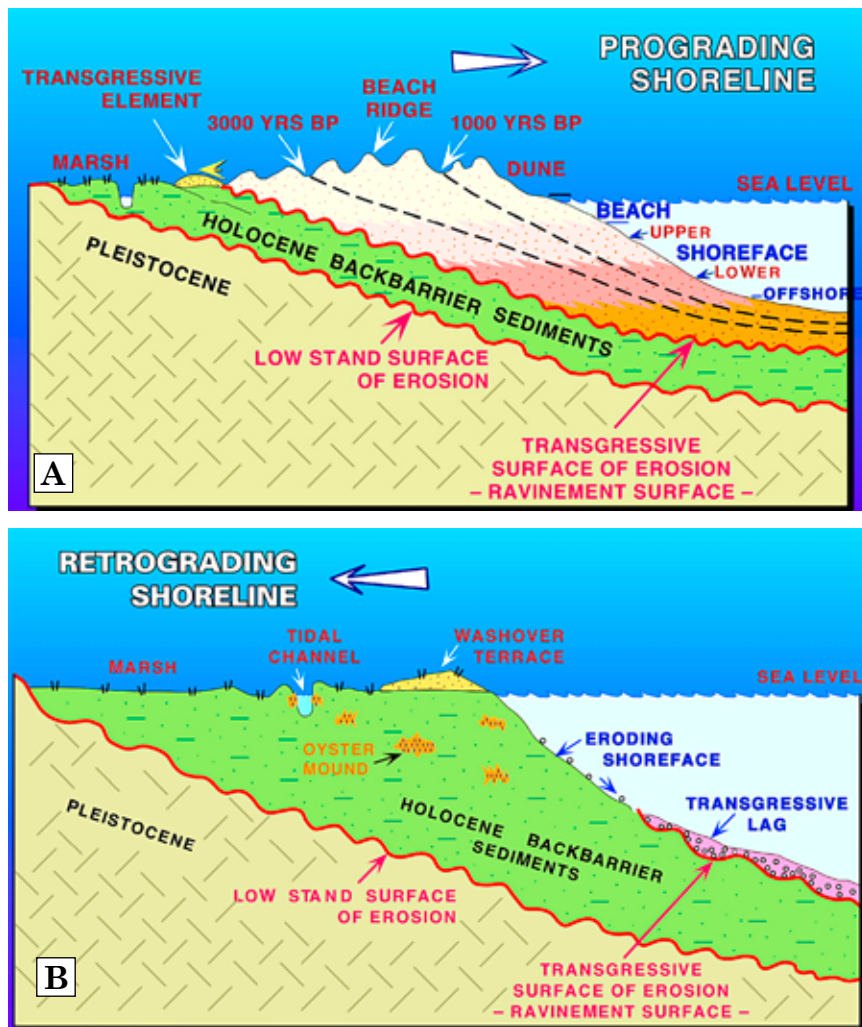
Figure 6. Cross section of barrier island geology and processes associated with: a) prograding island formation and b) retrograding island formation (from slide presentation of M.O. Hayes, Cape Romain National Wildlife Refuge files).

low water. Long shore drift and bar welding causes the distinctive island drumstick pattern as winds move sands to the south, eroding the northern portions and creating a recurved spit in the southern portion of islands, while the central portion remains somewhat stable. The north or updrift end is commonly wider containing old vegetated dunes whereas the southern or downdrift end is narrower or hook shaped similar to Bulls Island (Fig. 7). Overall the Quaternary geologic characteristics of island morphology in this region (Fig. 4) are related to the “stratigraphic, geometric, and mechanical character of subsurface stratigraphic units and long-term evolution of the coastal regions” (Harris et al. 2005; Fig. 6).

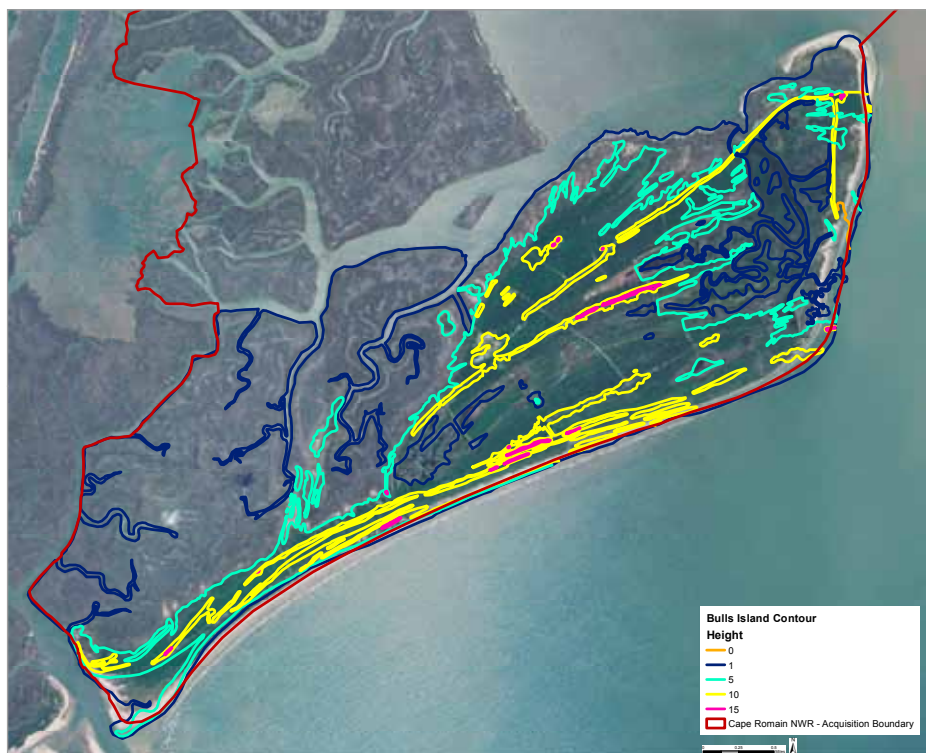
Figure 7. Shape and elevation contours (feet amsl) of Bulls Island on Cape Romain National Wildlife Refuge (data from refuge).

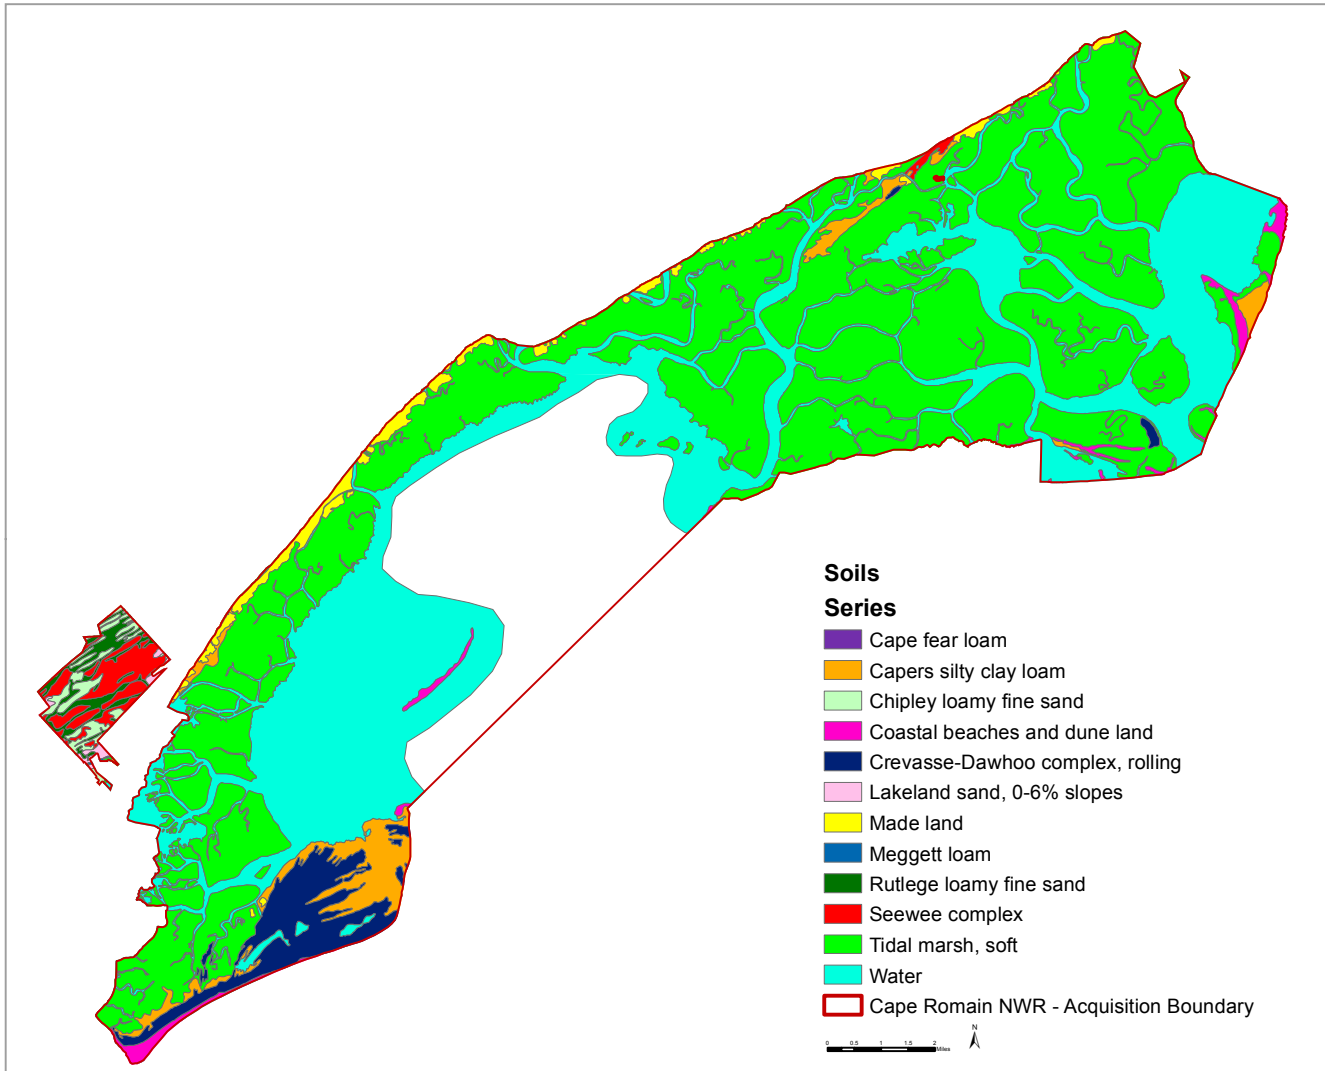
Figure 8. Soil types on Cape Romain National Wildlife Refuge (USDA SSURGO data, <http://websoilsurvey.nrcs.usda.gov>).

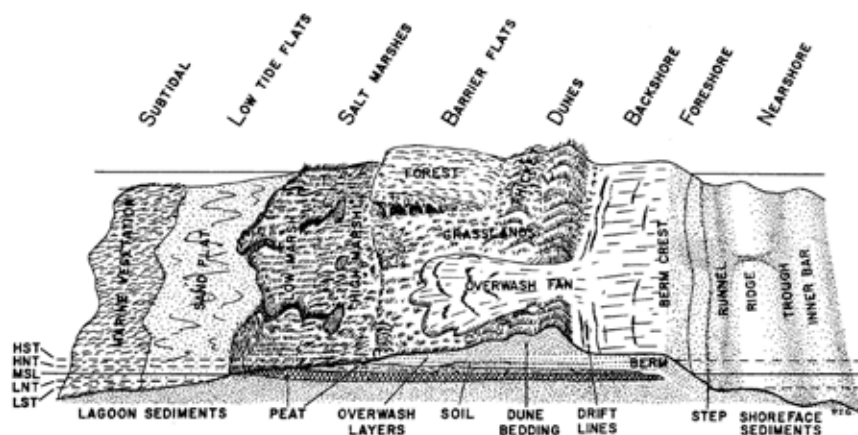
Figure 9. Cross section of barrier island topography (from Hayes and Michel 2008).

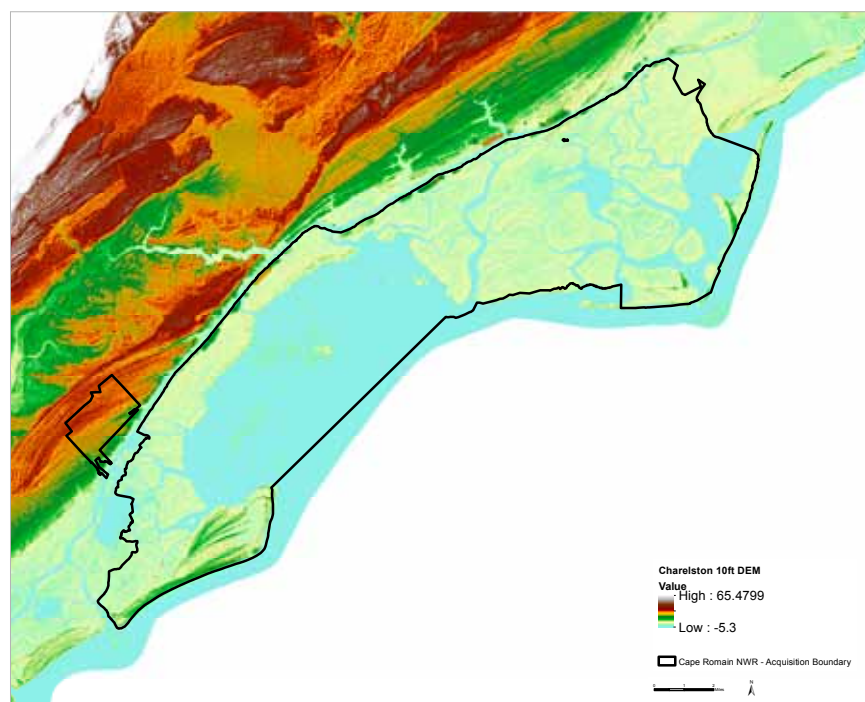
Figure 10. Digital elevation model (10 ft. DEM) for Cape Romain National Wildlife Refuge.

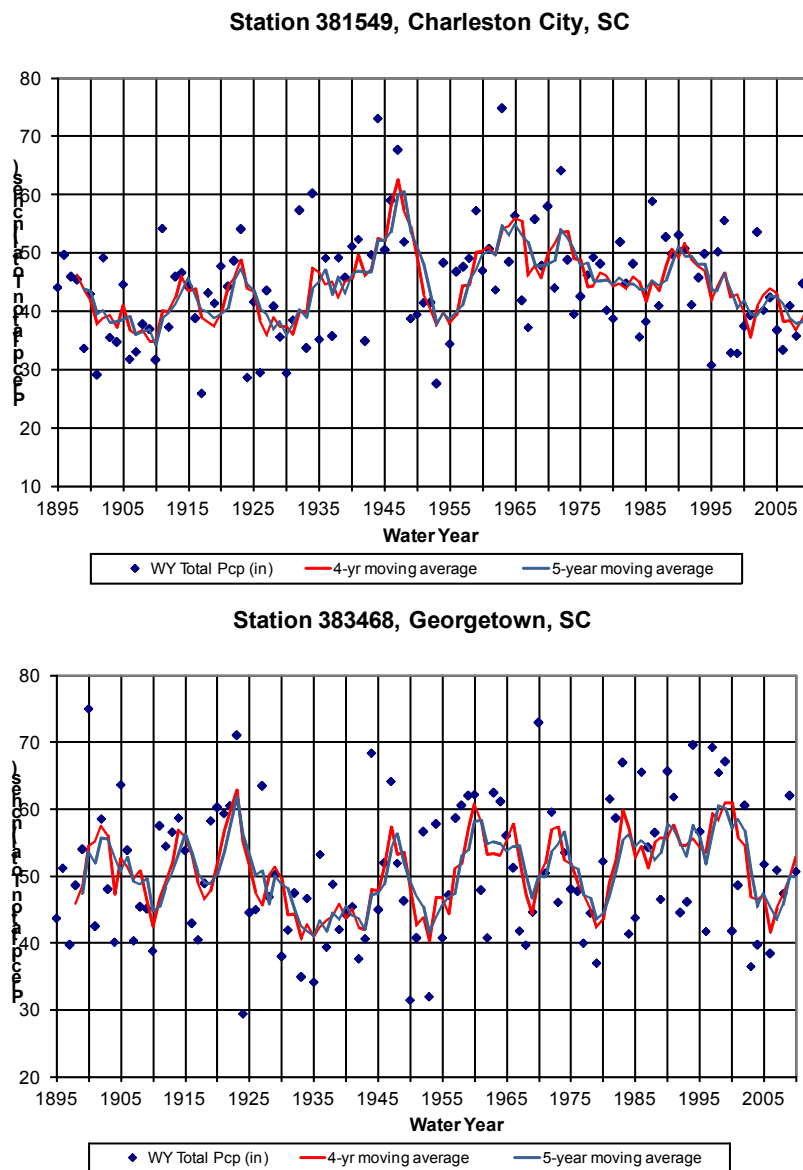
Figure 11. Total water year precipitation from 1895-2010 at Charleston and Georgetown, South Carolina (from Faustini et al. 2013).

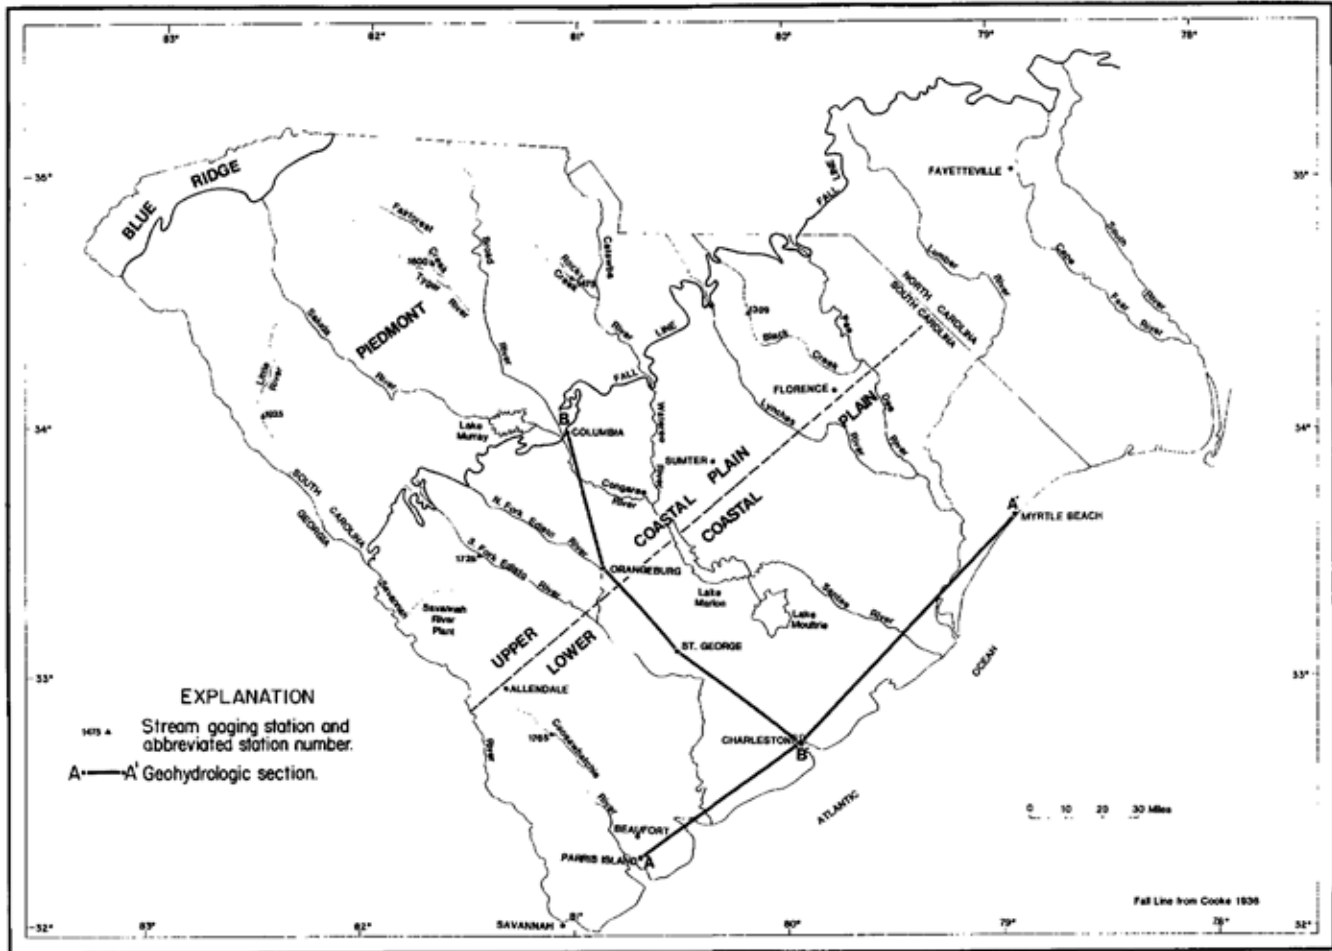
Figure 13. Location of the Upper and Lower Coastal Plains in South Carolina (from Aucott and Speiran 1985).

The Coastal Plain in South Carolina has been divided into a lower and upper plain based on groundwater flow and aquifer discharge (Fig. 13; Aucott and Speiran 1985). Six groundwater aquifers associated with the lower coastal plain were identified by Aucott (1996) ranging from the surficial Pleistocene aquifer comprised of coastal terrace deposits that are up to 40 feet in depth to the Late Cretaceous Cape Fear Formation Aquifer that is over 1,600 feet deep (Table 4, Fig. 14; Aucott and Speiran 1985; Harwell et al. 2004). Other detailed hydrostratigraphy identified eight aquifers separated by seven intervening confining

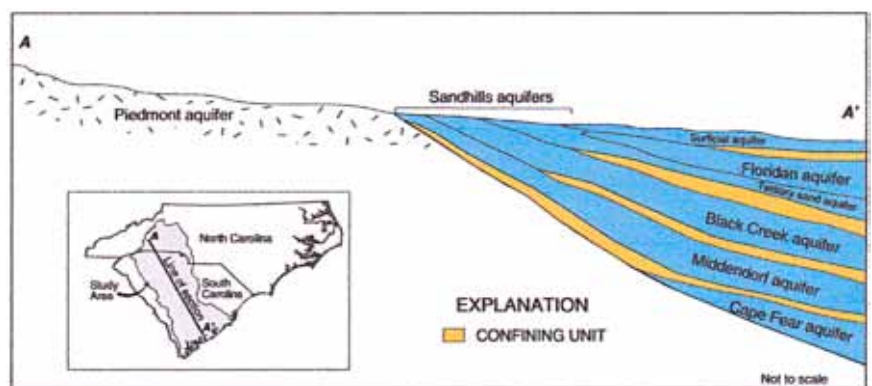
Figure 14. Location of groundwater aquifers in the Lower Coastal Plain of South Carolina (from Hughes et al. 2000).

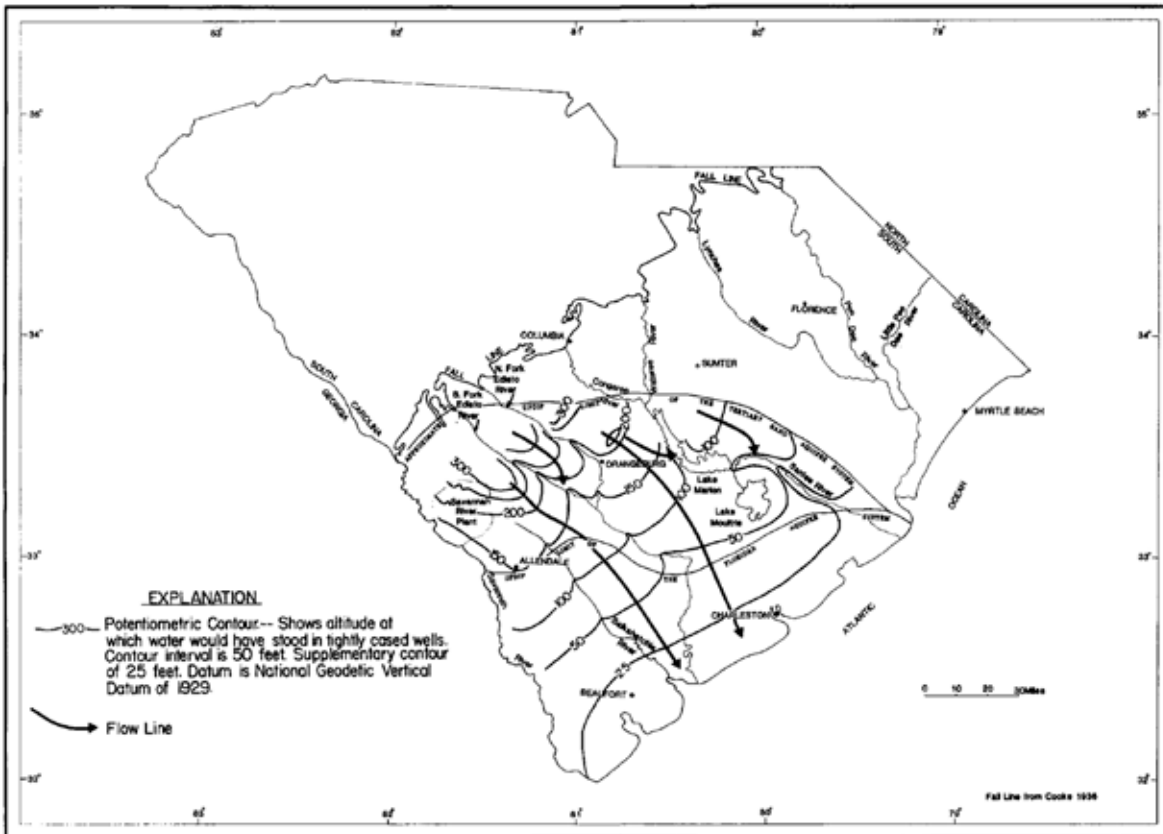
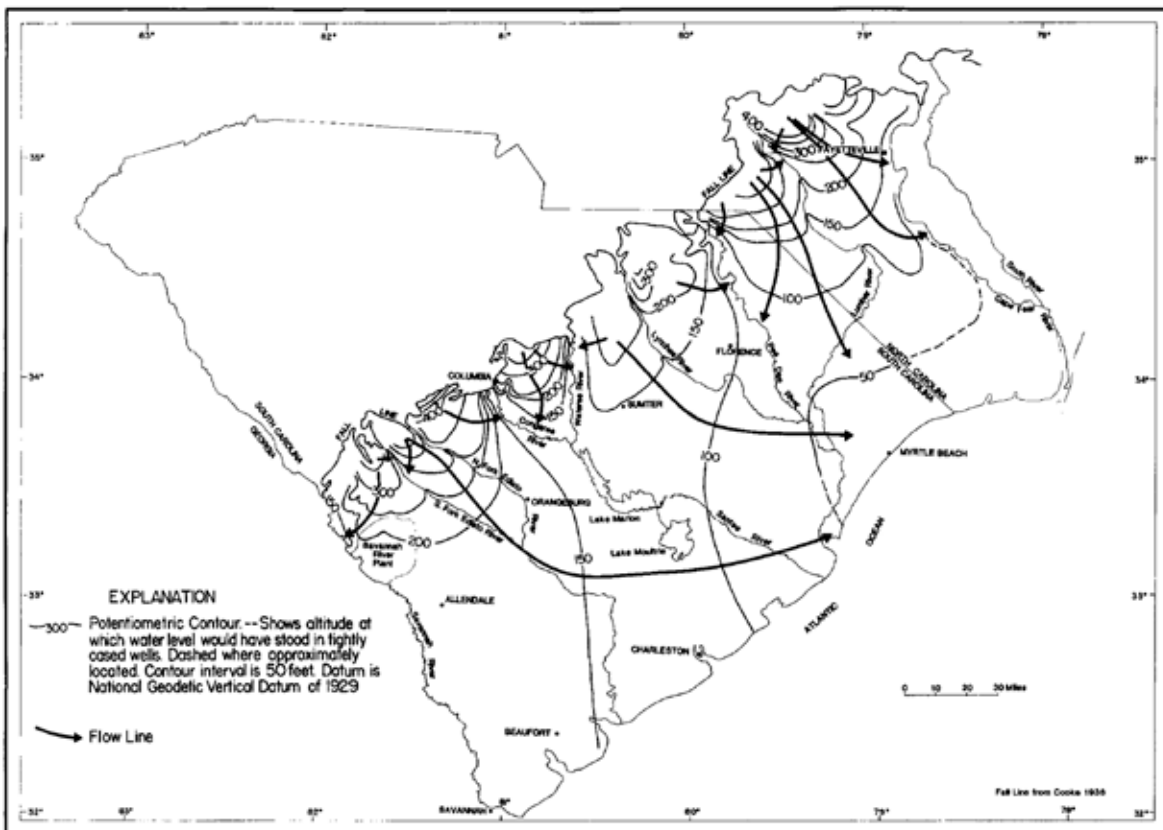
Figure 15. Groundwater flow patterns in different aquifers in South Carolina (from Aucott and Speiran 1985).

Groundwater flow within the lower coastal plain differs dependent on aquifer system. The Floridan and Tertiary systems flow patterns are toward the coast and somewhat towards major rivers while those below are more sluggish and flow towards the east, loosely paralleling the coastline, specifically near the Cape Romain NWR area (Fig. 15, Aucott and Speiran 1985).

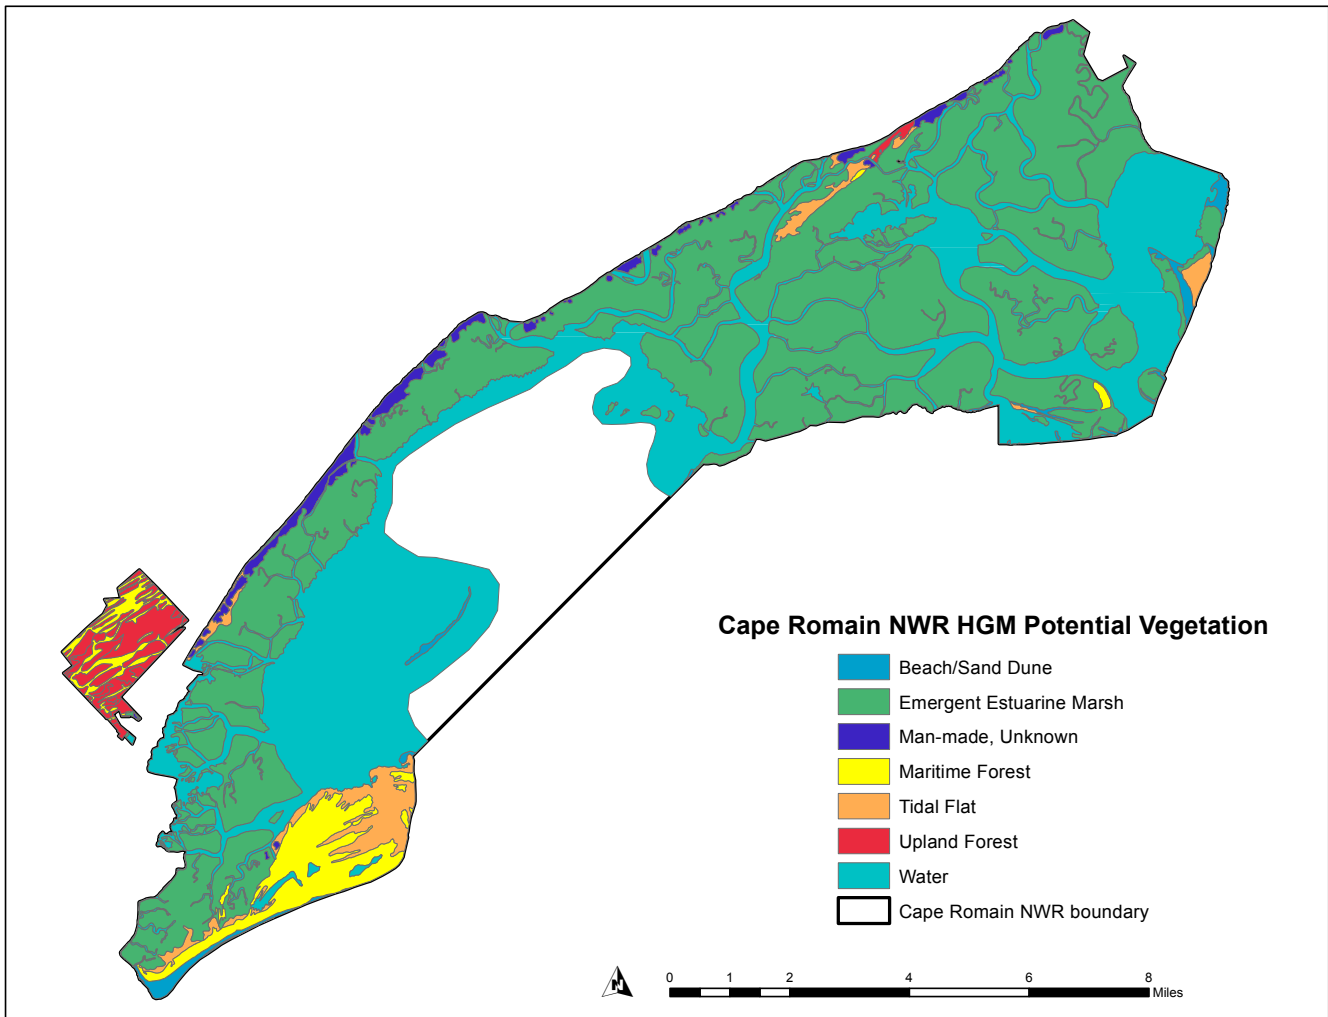
Figure 16. Potential historical pre-settlement vegetation community distribution within the Cape Romain National Wildlife Refuge acquisition boundary based on HGM attribute relationships summarized in Table 5 of this report.

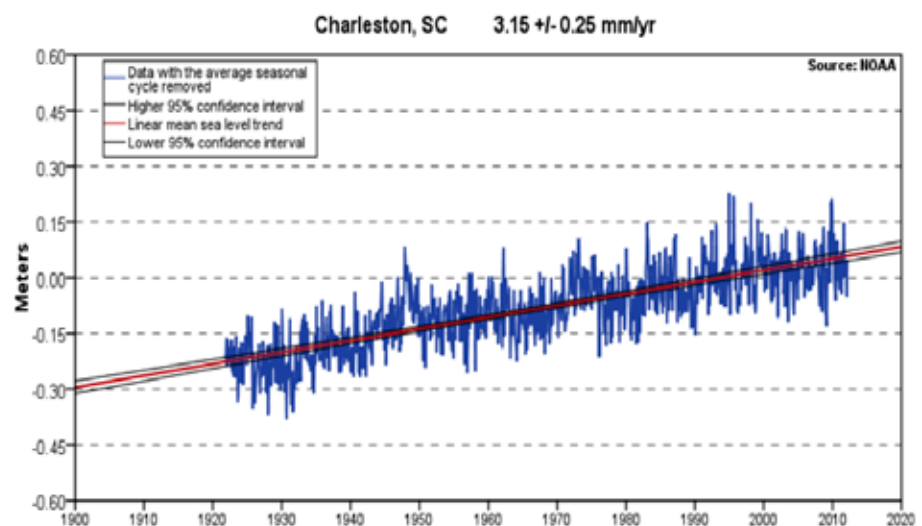
Figure 17. Mean sea level trend at Station 8665530 in Charleston, South Carolina. Data from <http://tidesandcurrents.noaa.gov> and presented in Faustini et al. 2013. Mean sea level trend is 3.15 mm/year with a 95% confidence interval of ± 0.25 mm/year based on monthly mean sea level data from 1921-2006.

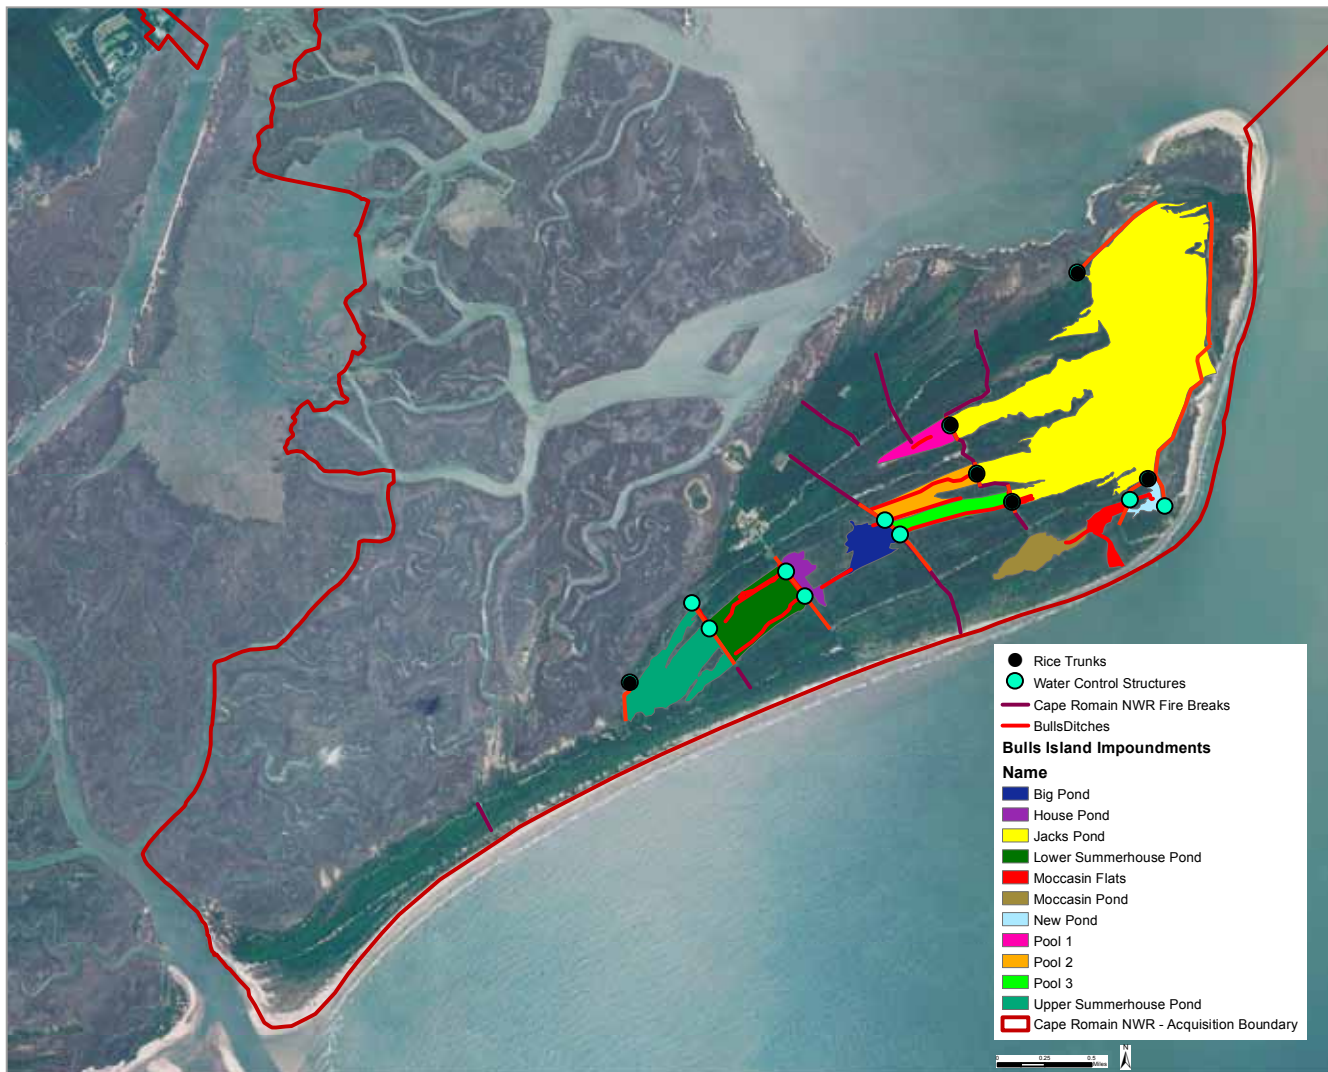
Figure 18. Wetland impoundments and water delivery infrastructure on Bulls Island, Cape Romain National Wildlife Refuge.

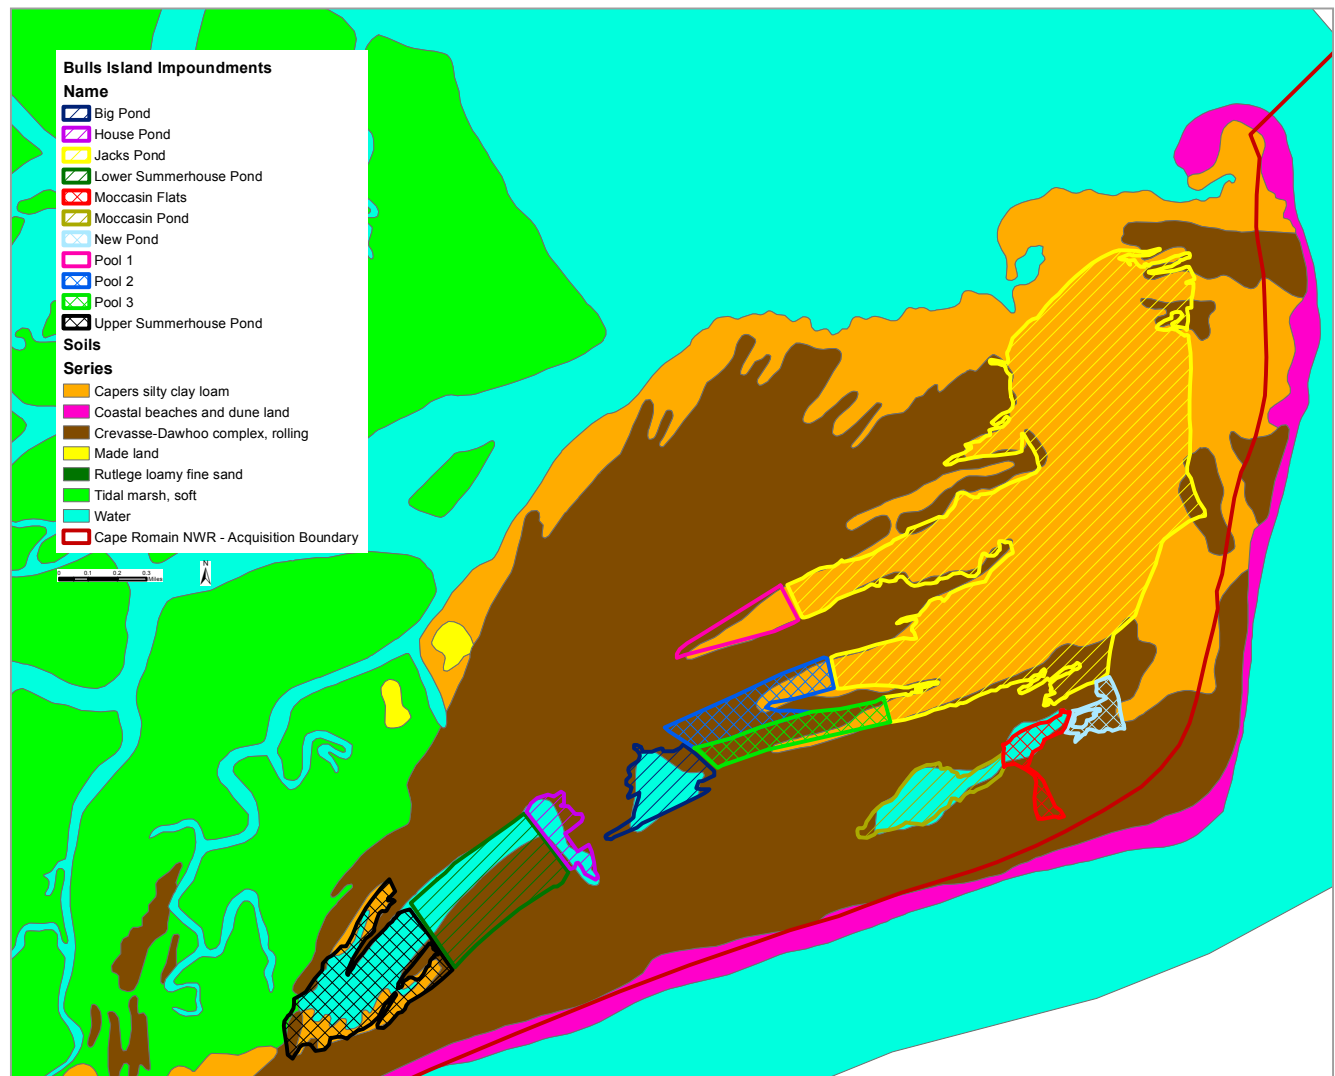
Figure 19. Bulls Island impoundments and water delivery infrastructure in relation to soils on Cape Romain National Wildlife Refuge.

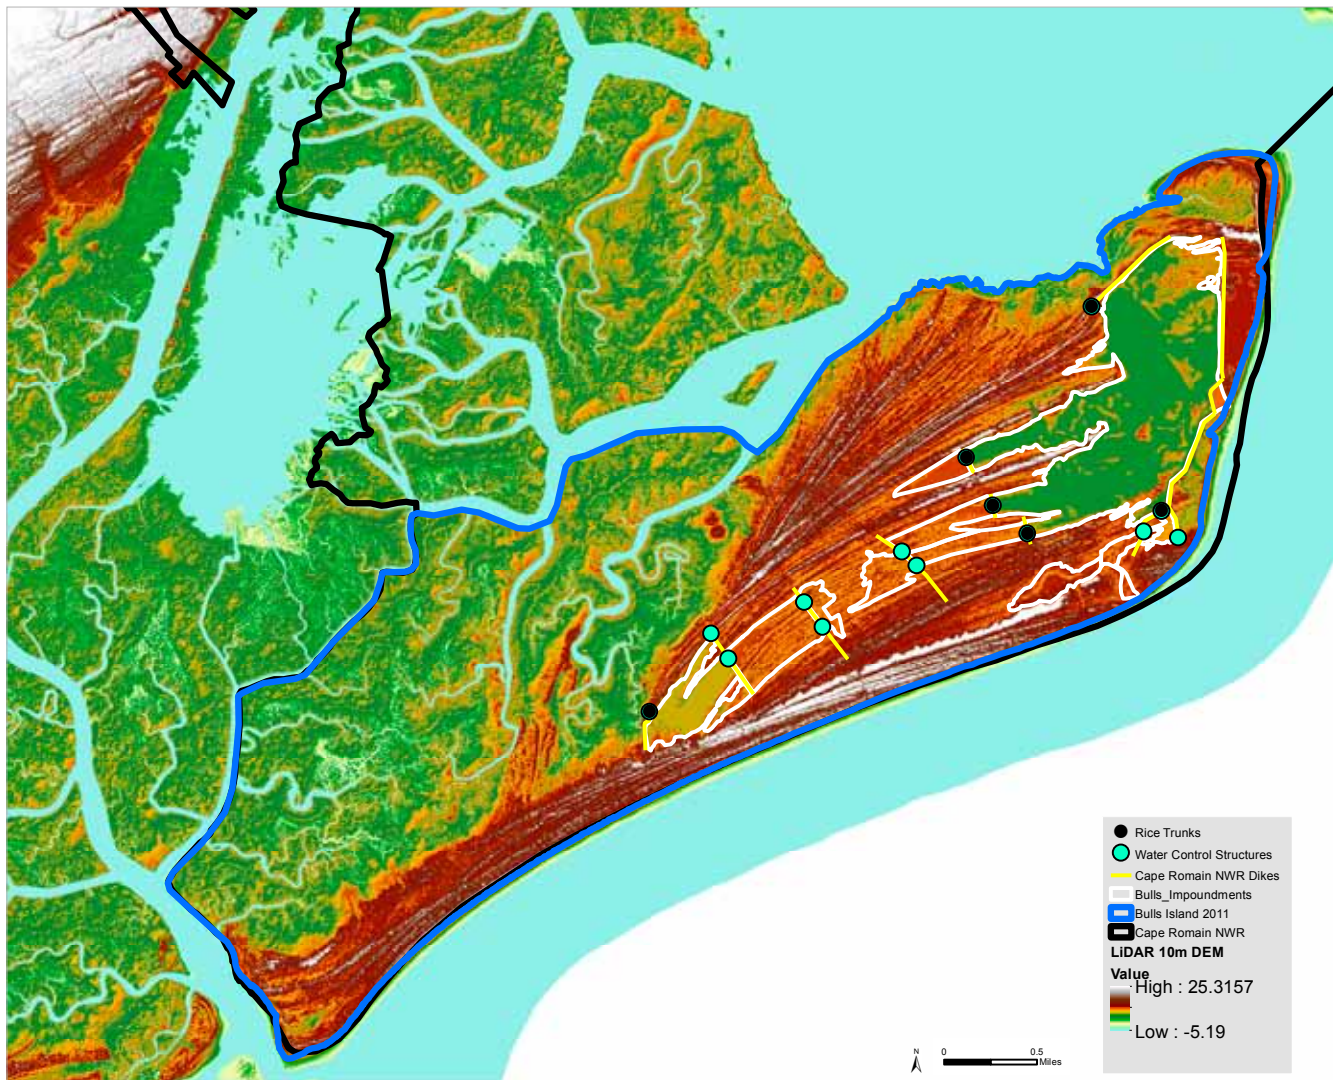
Figure 20. Wetland impoundments on Bulls Island in relationship to LiDAR 10 ft. elevation (data from refuge files).

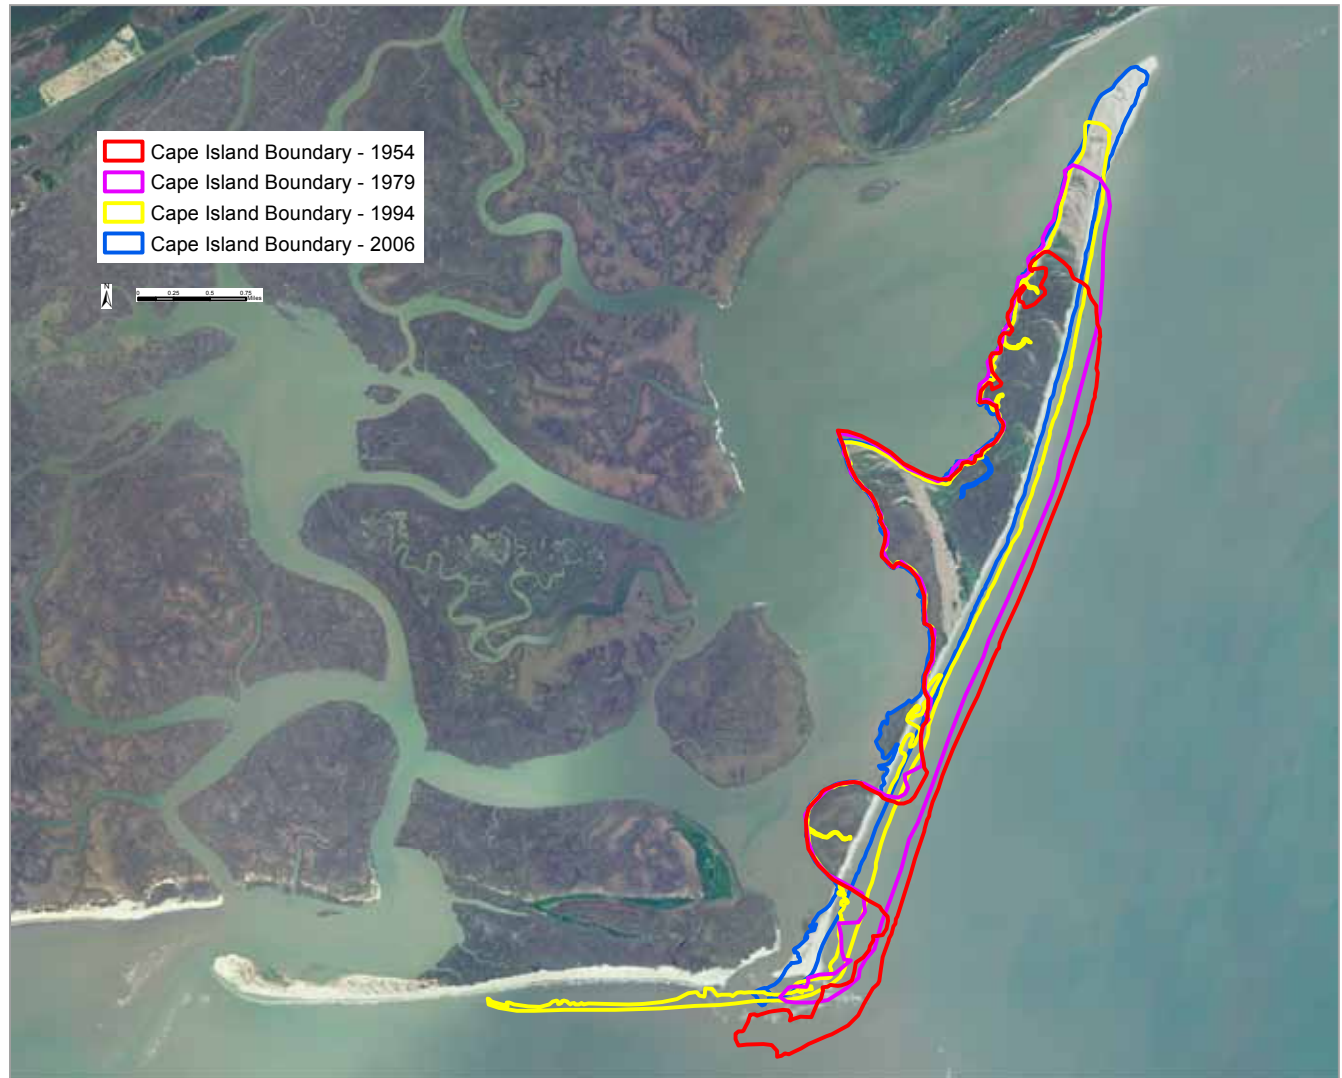
Figure 21. Sequential erosion and accretion of Cape Island from 1954 to 2006 at Cape Romain National Wildlife Refuge (provided by Dan Ashworth, Cape Romain NWR).

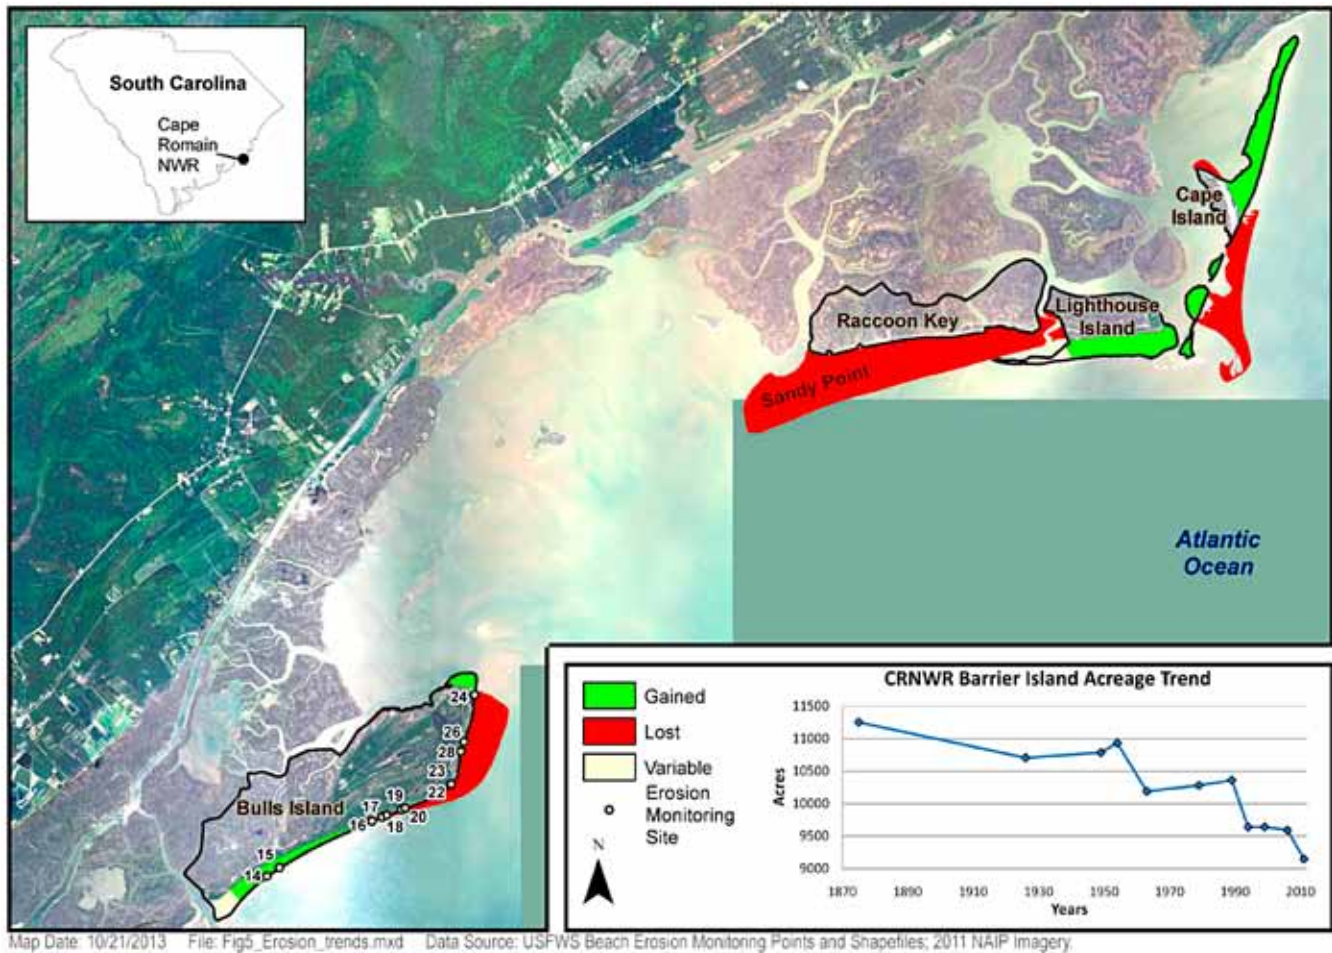
Figure 22. Net erosion and deposition on barrier islands at Cape Romain National Wildlife Refuge, 1875 to 2011. Numbered points on Bulls Island show locations of 2010-2012 ground-based erosion measurements taken by Cape Romain National Wildlife Refuge staff (from Faustini et al. 2013).

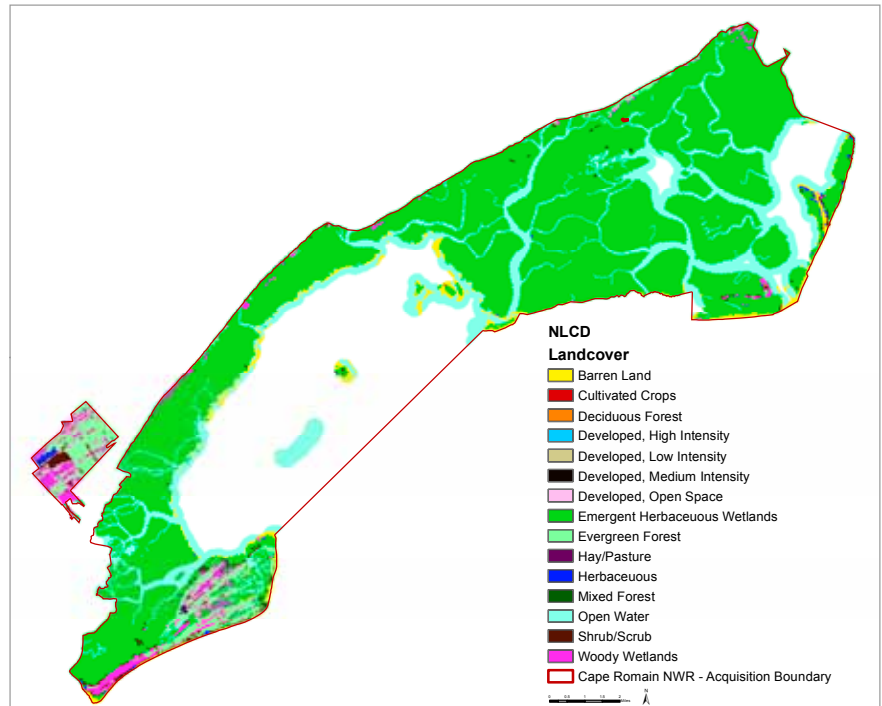
Figure 23. Landcover types taken from National Land Cover database on the Cape Romain National Wildlife Refuge (<http://datagateway.nrcs.usda.gov>).

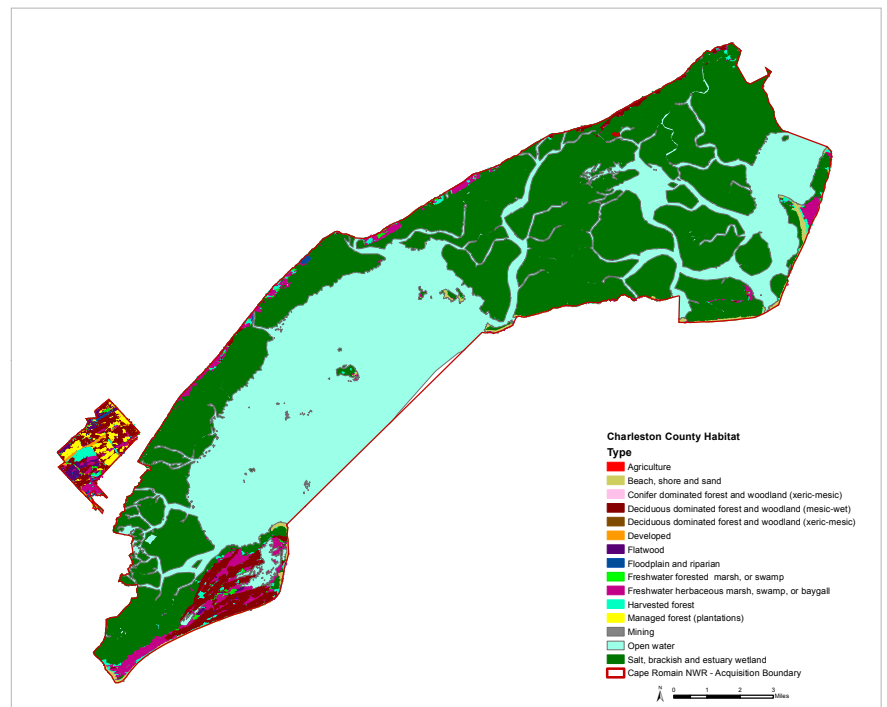
Figure 24. Habitat classifications on Cape Romain National Wildlife Refuge (from Charleston County, South Carolina GIS data provided by Cape Romain National Wildlife Refuge staff).
